DEPARTMENT OF TRANSPORTATION

Contract #: 04-0120F4Cty: SF/ALA Rte: 80 PM: 13.2/13.9File #: 69.28**WELDING INSPECTION REPORT****Resident Engineer:** Pursell, Gary**Address:** 333 Burma Road**City:** Oakland, CA 94607**Report No:** WIR-014941**Date Inspected:** 15-Jun-2010**Project Name:** SAS Superstructure**OSM Arrival Time:** 700**Prime Contractor:** American Bridge/Fluor Enterprises, a JV**OSM Departure Time:** 1900**Contractor:** Zhenhua Port Machinery Company, Ltd (ZPMC), Changxing Island **Location:** Shanghai, China

Bridge No: 34-0006**Component:** Tower Components**Summary of Items Observed:**

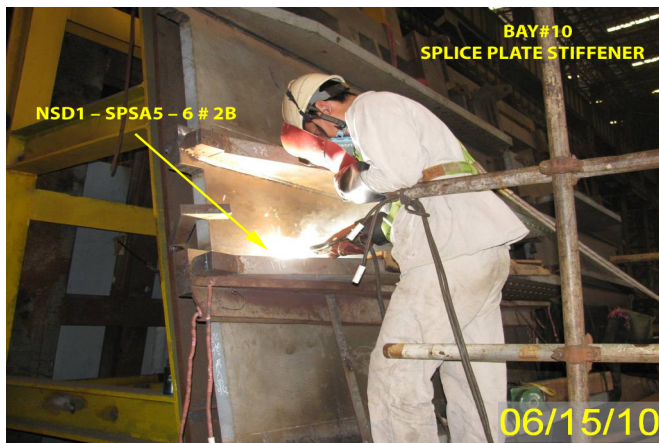
Weld joint # 2B located on Lift-5 Splice Plate Stiffener NSD1 – SPSA5 – 6. Welder is identified as 044511. ZPMC Quality Control (QC) Inspector is identified as Yu Zhi Lai. The welding variables recorded by QC appeared to comply with the WPS – B – T – 3211 – Tc – U5b – 1. (See attached photo)
